# Restoring Salmon Creeks Tidal Processes to Create a Diversity of Estuarine Habitats

#### **Michael Love P.E.** Michael Love & Associates, Inc. Eureka, CA

Project Goals and Objectives Enhance the diversity of the Salmon Creek Estuary while working within the physical constraints and multi-species management objectives of the Refuge

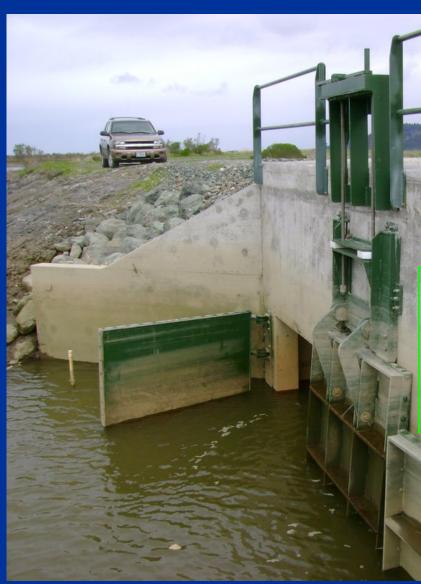
# Salmon Creek Muted Tide Gates (constructed 2008)

New Gates enlarge muted tidal prism (MLLW to MHHW) from 35 AF to 130 AF

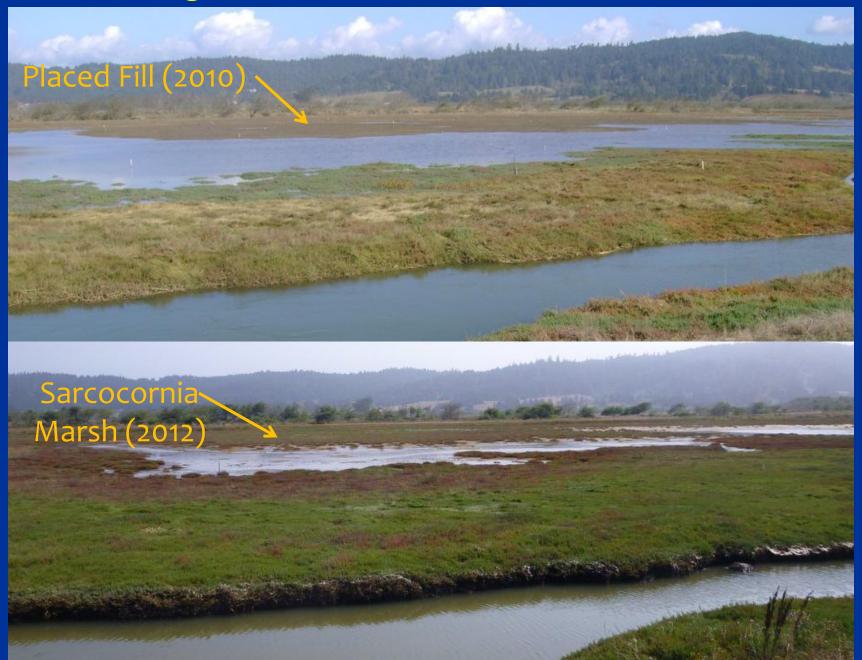
#### Salt Marsh Vegetation Recruitment -Salmon Creek Overflow

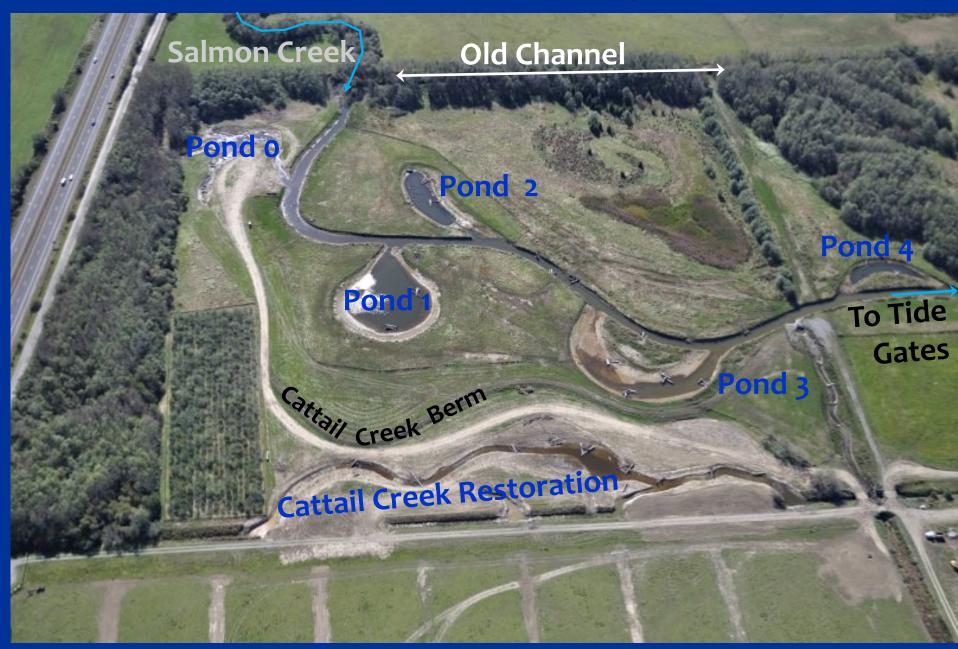
### Off-Channel & Side-Channel Ponds (Constructed 2011)

Pond Number	Pond Outfall Station	Outfall Weir Elevation (NAVD 88)	Tidal Prism from Pond	Residual Pool Depth
1	40+30	2.5 feet	1.4 AF	3.5 feet
2	38+25	3.0 feet	0.6 AF	3.0 feet
3	35+75 Upstream	3.5 feet	1.5 AF	3.8 feet
	33+00 Downstream	2.8 feet		3.0 TEEL
4	29+75 Upstream	3.0 feet		r o foot
	27+50 Downstream	3.5 feet	0.35 AF	5.0 feet

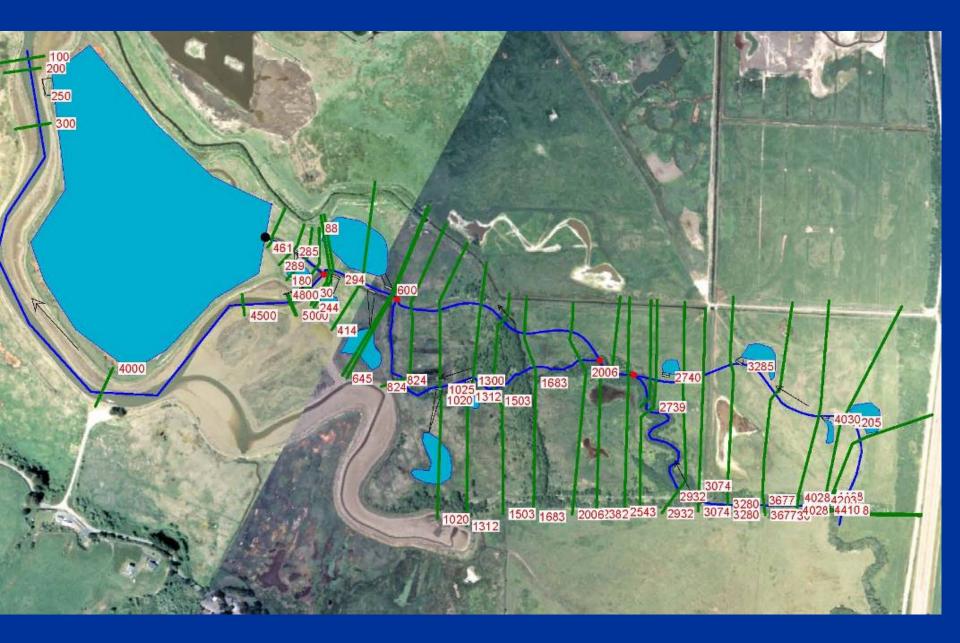
#### Unsteady HEC-RAS Model of Proposed Project

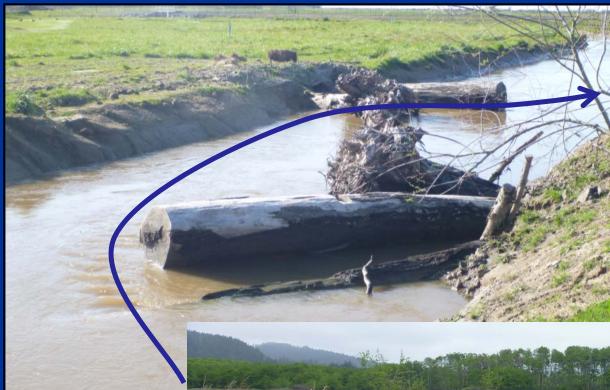
### 20 In-Channel Large Wood Structures

Deflector Logs to force local scour around Pond Mouths

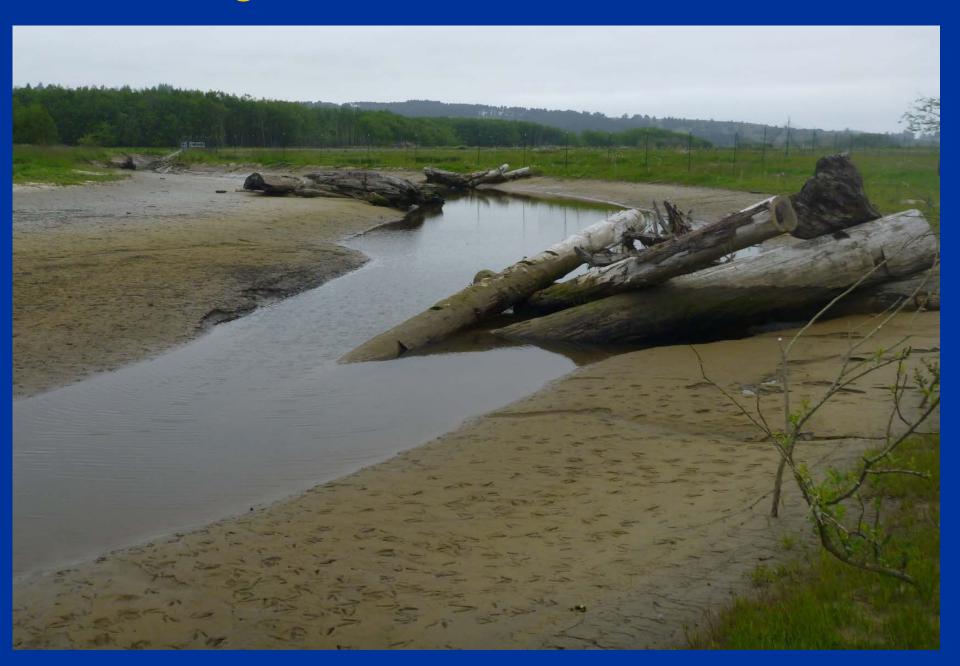
# Large Wood Structures at Low Tide

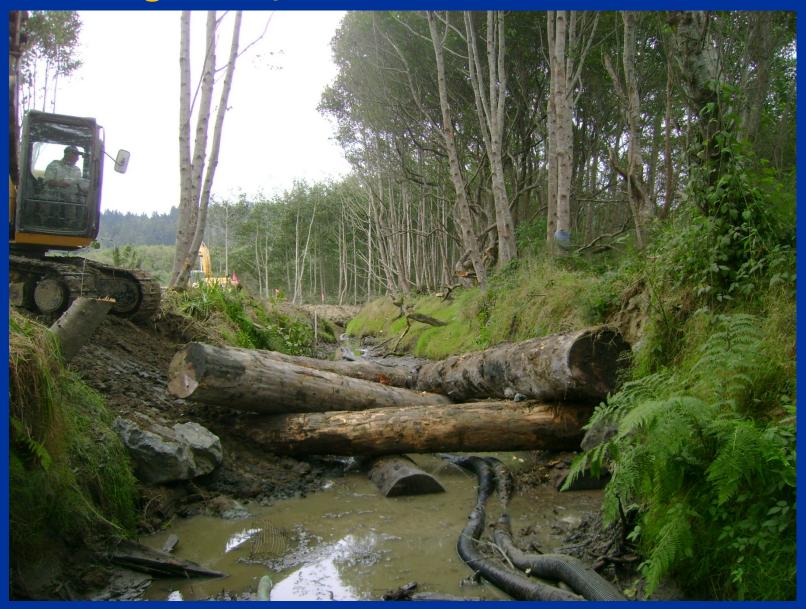
# Large Log Jam to Create Low-Flow Blockage at Upstream end of Old Channel
