Salmonid Restoration Federation – Fish Passage Design Workshop

Morrison Gulch – Case Study

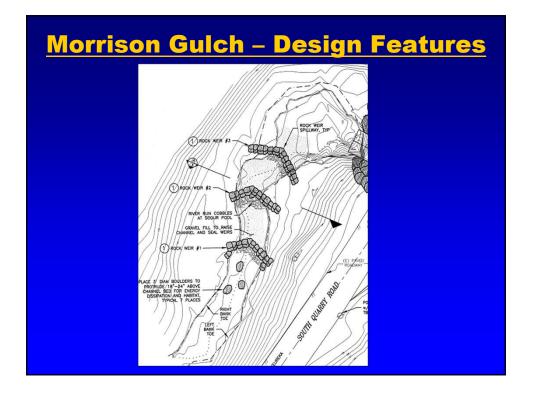
<u> Morrison Gulch – Design Features</u>

- Slope through culvert = 0.0%.
- Elevation of downstream weir relative to culvert outlet = 0.5 feet higher.
- Design concept install culvert, then construct grade-control weirs.
- Elevation between grade-control weirs = 0.5 feet.

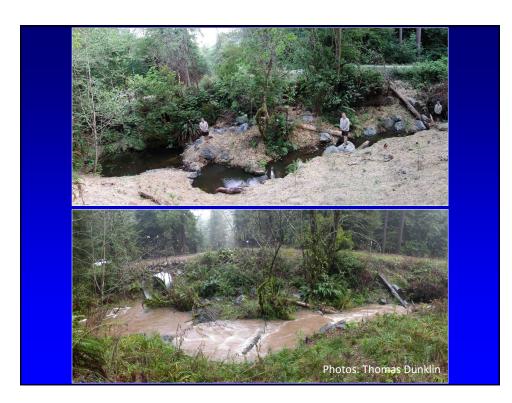
Project Stability and Longevity

- Resurveyed downstream weirs and culvert inlet and outlet on May 5, 2017.
- Slope through culvert = 1.31%.
- Elevation of 1st downstream weir relative to culvert outlet = 0.27 feet higher.
- Elevation between 1st and 2nd weirs = 0.78 feet.
- Elevation between 2nd and 3rd weirs = 0.79 feet.

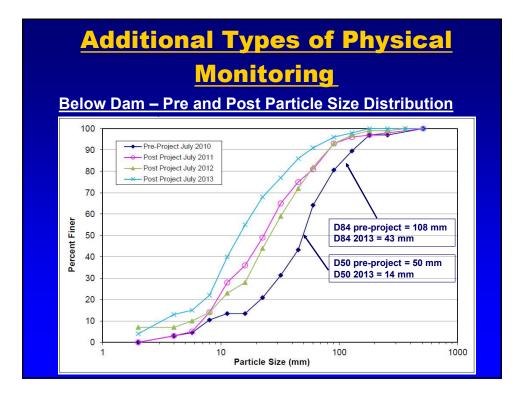
Glenbrook Gulch/Albion River – Dam Removal Project

<u>Downstream of Dam:</u> channel scoured to bedrock with large angular substrate. No suitable spawning habitat.

<u>Solution:</u> install channel-spanning boulder and log structures to capture mobilized sediment. Minimal removal of stored sediment during dam removal.

<u>Monitoring:</u> photo points, longitudinal thalweg surveys and pebble counts (pre and post).
